More, 04.02.2025

- Photogrammetric documentation of the Caroline's Dungeon —→

## Fort Nassau

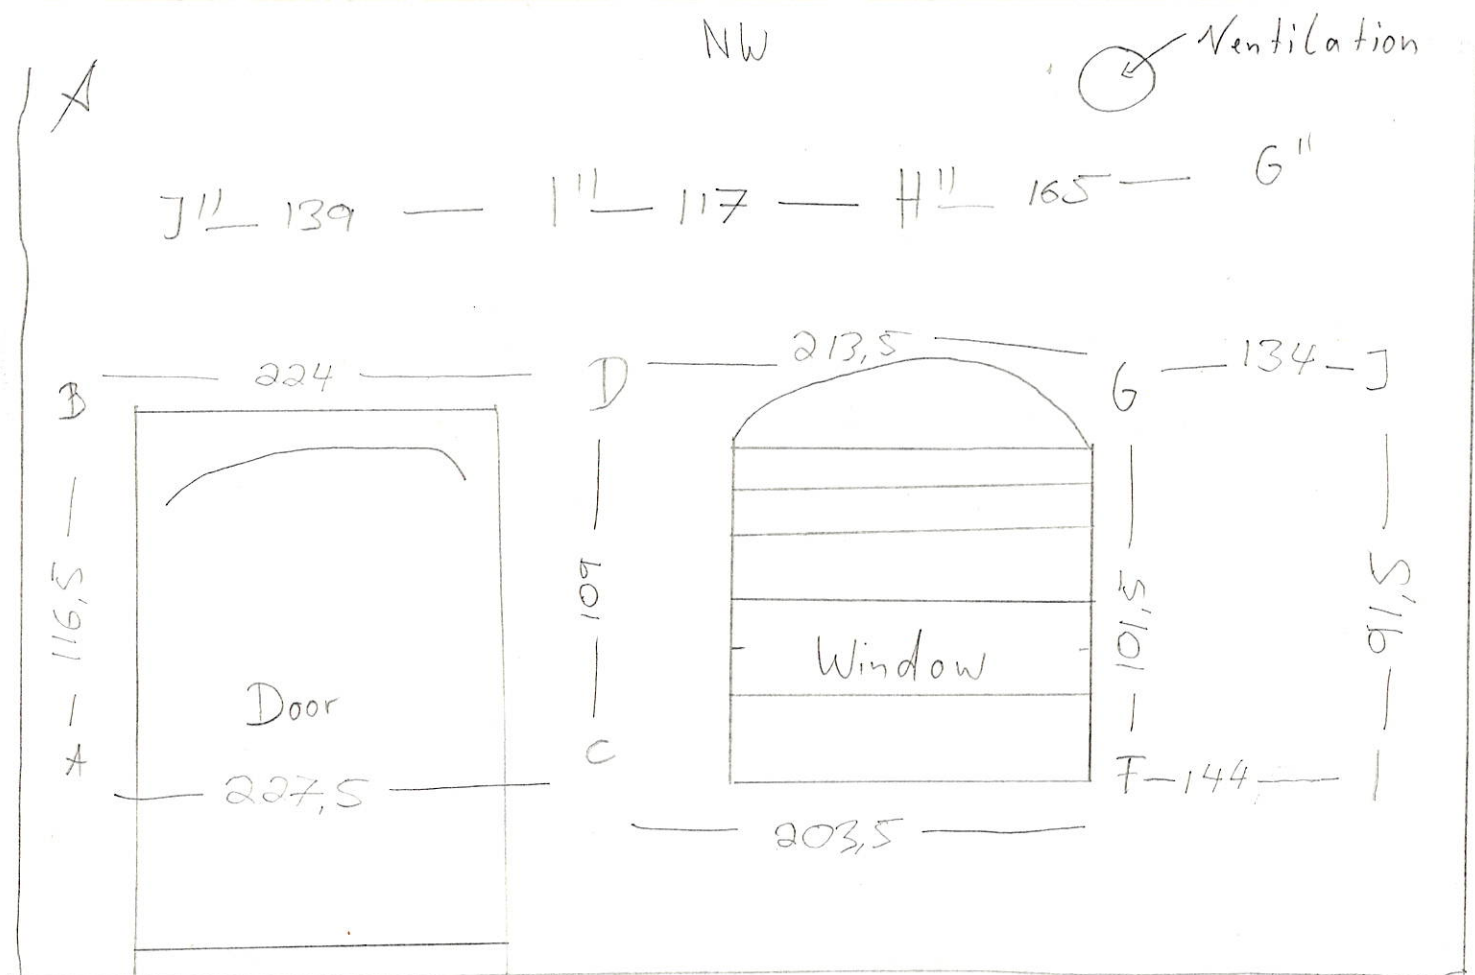
I could get a sense of the extreme conditions while working in this dungeon, and especially while taking the photographs. Time seemed much longer than it actually was when taking the pictures in the dungeon. Humidity (>90%) and temperatures (~28,5°C) made me sweat like crazy. There was mold all over the walls. The ventilation opening didn't seem to help.
